CHARACTERISTICS AND DESIGN OF INONG BALEE FORT BINDING MORTAR FOR RESTORATION PURPOSES

Muttaqin Hasan^{*}, Teuku Budi Aulia^{**}, Fido Yurnalis^{***}

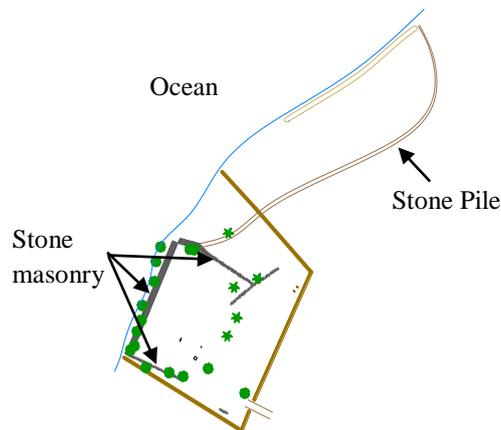
Figure 2. Plan of Inong Balee Fortress

The main part of the fort is made of stone masonry with a thickness of 2 m and a height of 2.5 m while the northwest aspect only has a stone structure as shown in Figure 2. According to estimates by the Medan Archeological Agency, the structure of the stone pairs is rectangular with a size of 60 m x 40 m while Hermansyah & Nasruddin (2013) showed the main raw materials for the fort consisted of river and mountain stones glued together with a mixture of limestone, clay, and sand as observed in other forts in Aceh built at the same time. Meanwhile, the adhesive was obtained by burning lime and shellfish.

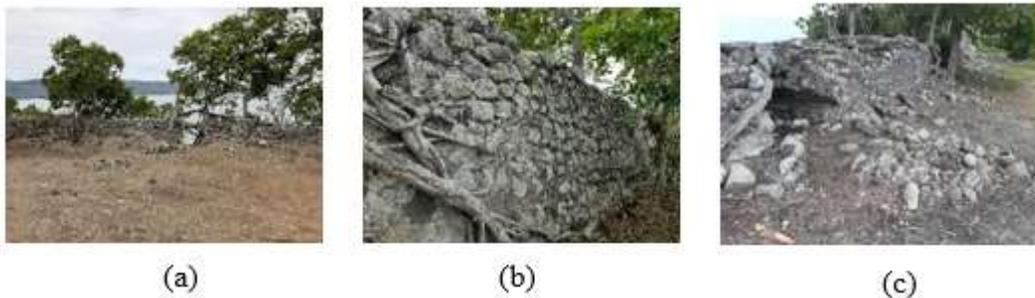
The fort currently only has walls on the north and west sides (Hermansyah & Nasruddin, 2013) while several parts of the masonry wall have been damaged and the stone has fallen from the mortar bonds (BPCB/Institute for Preservation of Cultural Heritage of Aceh, 2016) as shown in Figure 3. The importance of this fort to the county in terms of archaeology, history, science, and education has made the Indonesian Government through the Institute for Preservation of Cultural Heritage of Aceh to plan a restoration process. Meanwhile, Indonesian Law no. 11/2010 Article 77 states that the restoration of cultural heritage has to pay attention to the authenticity of the material, shape, layout, style, and workmanship technology. Therefore, it is necessary to know the characteristics of the binding mortar used during the fort construction in order to design a new

Figure 3. The current condition of Inong Balee Fort: (a) The west side wall; (b) Sea side wall; (c) The stones that had fallen from the fort walls

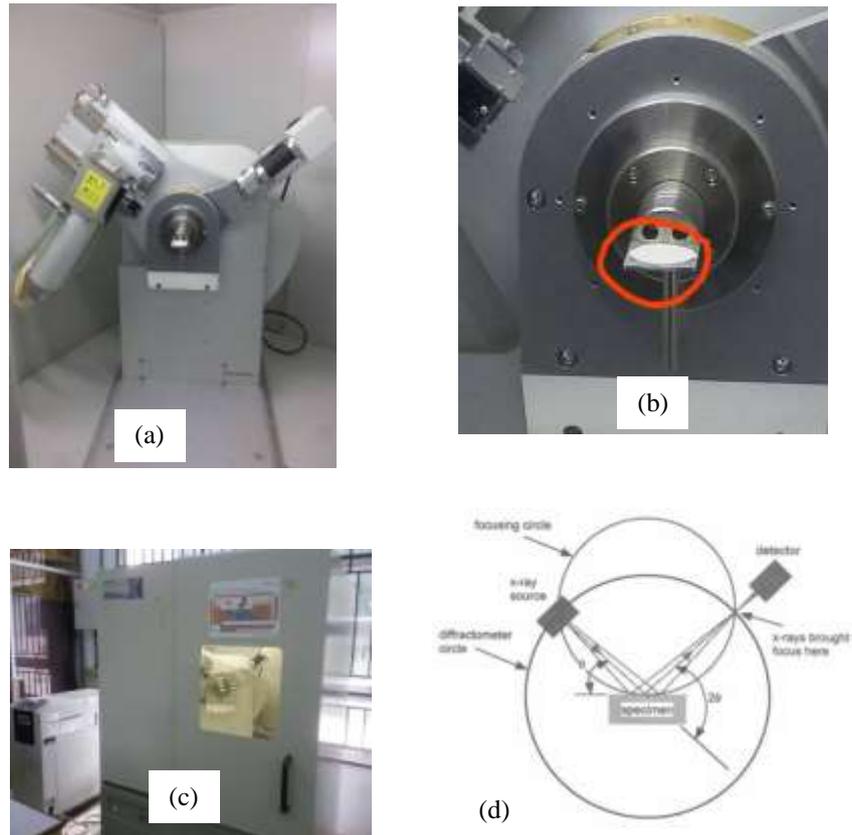
Figure 4. XRD test on samples: (a) setting of XRD devices (b) placement of the sample powder on the peak (c) sample characterization process (d) the working principle of XRD devices

The sieved powder samples were characterized using the X-Ray Diffraction (XRD) test through the use of a Maxima XRD-7000 device made by SHIMADZU as shown in Figure 4. The XRD device uses X-ray radiation from XRD pipes with wavelengths of 0.154184. This test was used to obtain the information on the crystal structure of the material (Suharyana, 2012) with the diffraction pattern produced observed to be in the form of diffracted X-ray diffraction intensity and angles of 2θ . Moreover, each pattern in the XRD represents a crystal plane with a certain orientation (Widyawati, 2012), and test results were further analyzed by matching them with the angle value obtained from the Joint Committee on Powder Diffraction Standards (JCPDS) database.

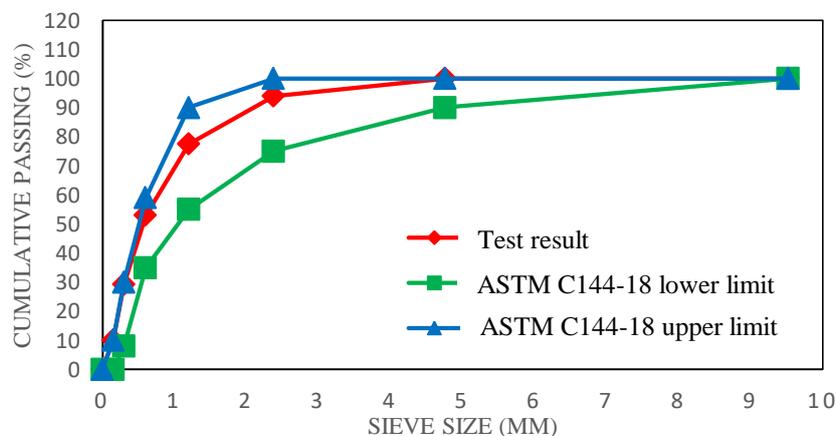
The materials used to design the mortar for restoration purposes are lime, cement, and sand. The lime was obtained by burning limestone (CaCO_3) in a furnace at a temperature of 1100°C while the cement was Portland Pozzolana Cement by PT Semen Andalas Indonesia with a specific gravity of 3.16. The sand has a maximum grain size of 4.75 mm and examined for its physical properties and grain grading before use with the results shown in Table 1 and Figure 5

Figure 5. Gradation of sand grains
Source: Test result

respectively. The sand was discovered to have met the aggregate requirements for mortar-forming materials as required in ASTM C144-18 as shown in Table 1.

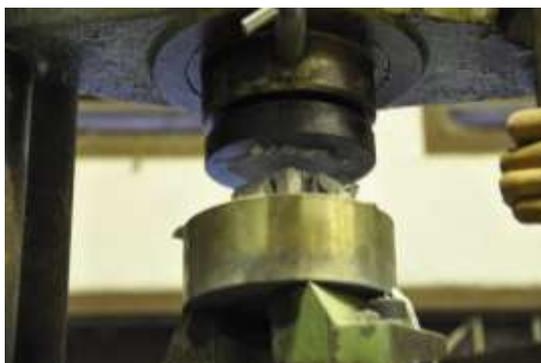
Figure 6. Compressive strength test for the mortar samples
Source: Author Documentation

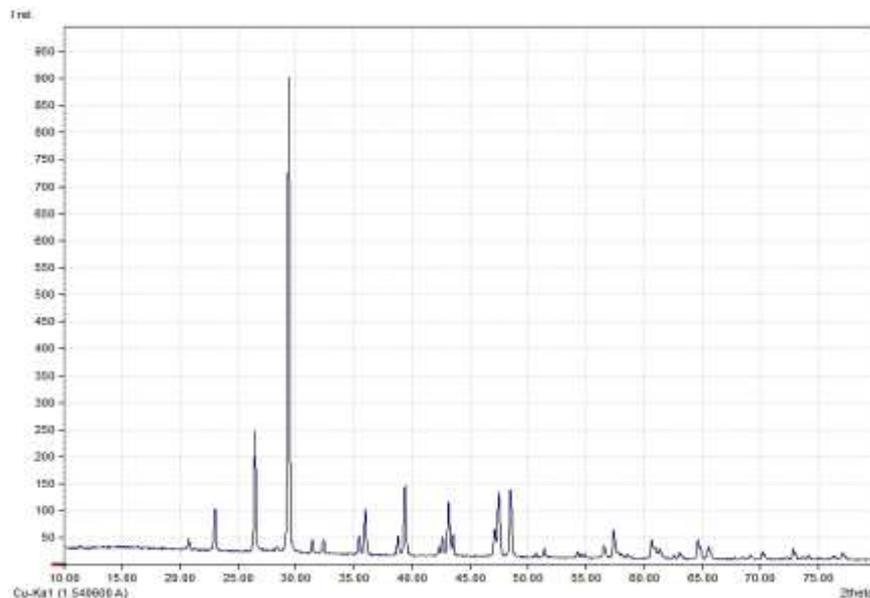
The XRD test results showing the pattern of the mortar sample in Inong Balee Fort are presented in Figure 7 and the highest peak was observed at an angle of 2θ of 29.410. This means the dominant compound in the fort mortar is CaCO_3 in the form of calcite limestone and the binding mortar was made of lime. The next peak was recorded at an angle of 2θ of 26.508 and this indicates the SiO_2 compound or silica is also dominant while the other compounds are P_2O_5 , MgCO_3 , and Al_2O_3 . Therefore, the mortar of Inong Balee Fort was confirmed to be made of lime and sand.

Figure 7. X-ray diffraction pattern of mortar in Inong Balee Fort

This research was conducted on the binding mortar of Inong Balee Fort and the specimens designed for restoration purposes. It was discovered that the main compounds in the binding mortar of Inong Balee Fort are CaCO_3 and SiO_2 with the main mineral being calcite while some others observed include P_2O_5 , MgCO_3 , and Al_2O_3 . Therefore, the binding mortar for the fort was made of lime and sand.

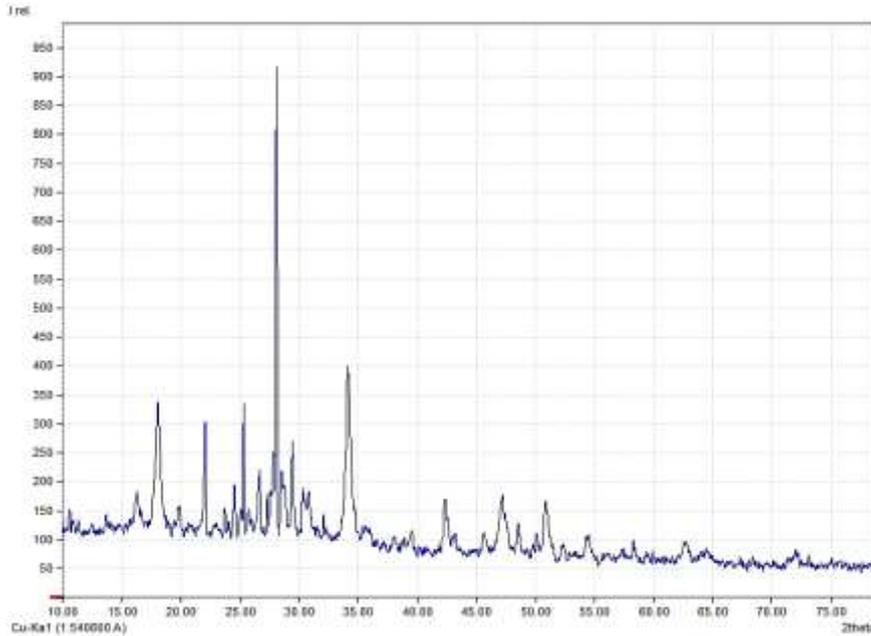
The X-ray diffraction pattern of A mixture mortar from the XRD test is presented in Figure 8 and was observed to be almost similar to those in the mortar of Inong Balee Fort. The compounds found in the mixture include CaCO_3 , CaO , SiO_2 , Al_2O_3 , Fe_2O_3 , MgCO_3 , $\text{MgCa}(\text{CO}_3)_2$, and P_2O_5 and this means it contains all the compounds contained in the Inong Balee Fort mortar. However, three additional compounds including CaO , Al_2O_3 , and $\text{MgCa}(\text{CO}_3)_2$ were also found in the mixture.

Figure 8. X-ray diffraction pattern of A mixture mortar
Source: Test Result

The main compound in the mortar with a mixture of 1 lime: 2 sand was found to be CaCO_3 and SiO_2 which is the same with Inong Balee Fort while others found in this specimen include CaO , Al_2O_3 , Fe_2O_3 , MgCO_3 , $\text{MgCa}(\text{CO}_3)_2$, and P_2O_5 . The mixture also has a compressive strength of 1.41 MPa and this is considered lower than the values required by SNI 6882: 2014 and ASTM C270-19a Standards which means it cannot be used for the masonry binding mortar. Meanwhile, the major compound in the mortar with a mixture of 1 cement: 2 lime: 3 sand was also CaCO_3 and SiO_2 which is similar to those observed in Inong Balee Fort while the others include CaO , Al_2O_3 , Fe_2O_3 , MgO , MgCO_3 , $\text{MgCa}(\text{CO}_3)_2$, and P_2O_5 . The compressive strength of the mixture was 2.45 MPa and this means it is a type O mortar group based on SNI 6882: 2014 and ASTM C270-19a Standards and applicable in interior and exterior wall binding mortars which do not carry heavy loads. Therefore, this mixture is usable in restoring the Inong Balee Fort as well as to preserve it for the future due to its strong structure.

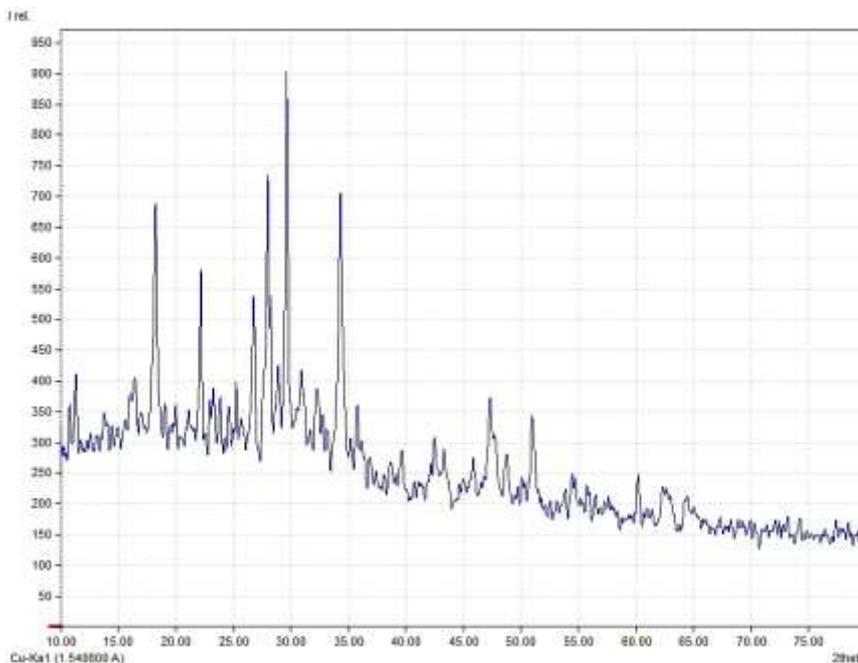
The X-ray diffraction pattern of B mixture mortar based on the XRD test is presented in Figure 9 and was found to also be almost similar to those in Inong Balee Fort and A mixture mortars. The compounds discovered in the B mixture mortar are CaCO_3 , CaO , SiO_2 , Al_2O_3 , Fe_2O_3 , MgO , MgCO_3 , $\text{MgCa}(\text{CO}_3)_2$, and

P₂O₅ and this means it has all those observed in A mixture and Inong Balee Fort mortars. However, B mixture mortar has another compound discovered not to be in A mixture mortar which is MgO, and several others not in Inong Balee Fort such as CaO, Al₂O₃, MgO, and MgCa(CO₃)₂.

Figure 9. X-ray diffraction pattern of B mixture mortar
Source: Test Result
